AMT Encoder Mounting Troubleshooting Guide

Applicable series: AMT11, AMT11A, AMT20, AMT21, AMT22, AMT23, AMT31

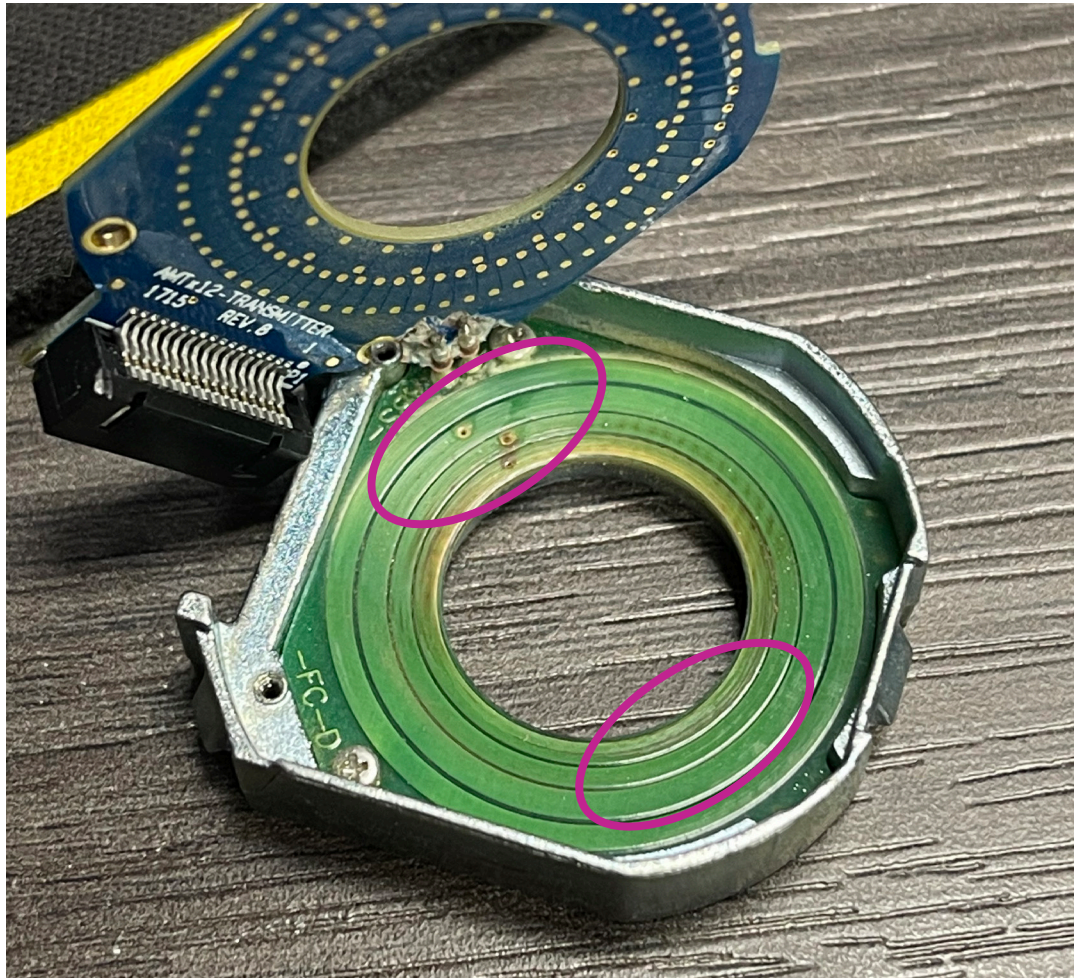
Figure 2

This image shows physical wear on the receiver PCB caused by improper mounting. The wear is also in a radial pattern, indicating that damage was caused by the rotor PCB rotating while in contact with the receiver PCB.

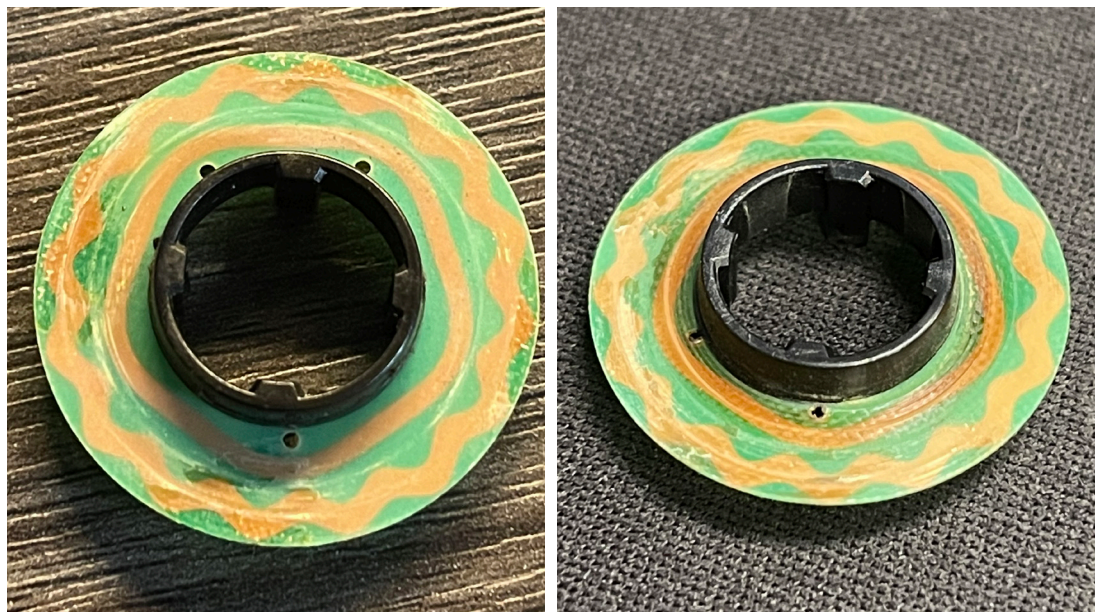
Figure 3

Here is the rotor PCB also showing significant signs of wear from rotation while improperly mounted. Heat damage is also visible due to prolonged use with significant friction.

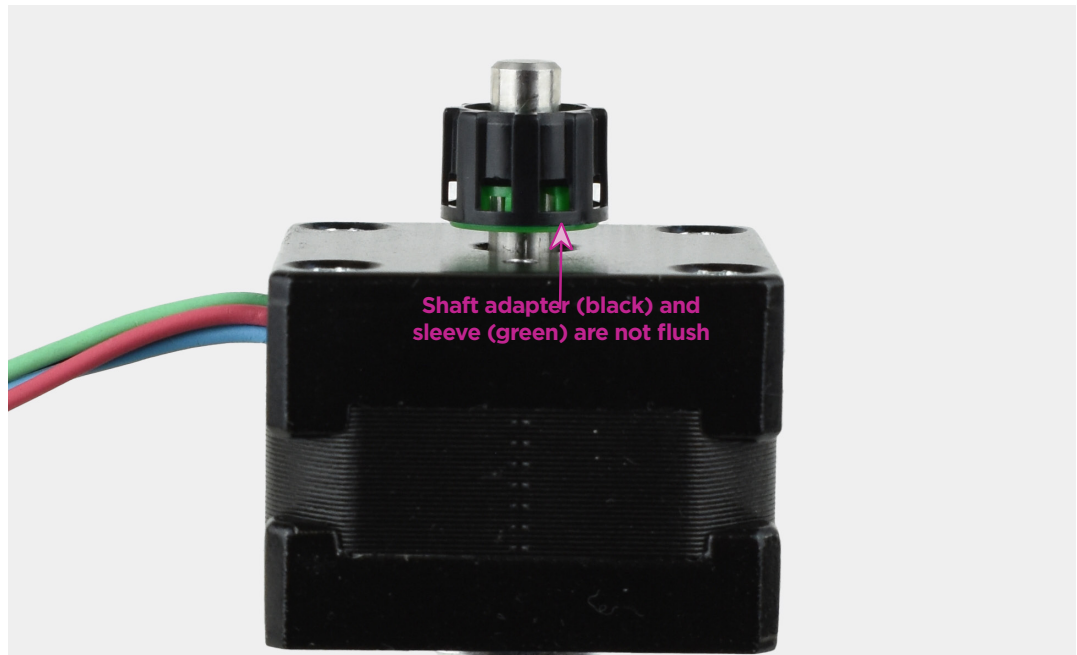
Figure 4

Improperly mounted shaft adapter and sleeve. The green shaft sleeve and black shaft adapter should be completely flush when properly mounted.

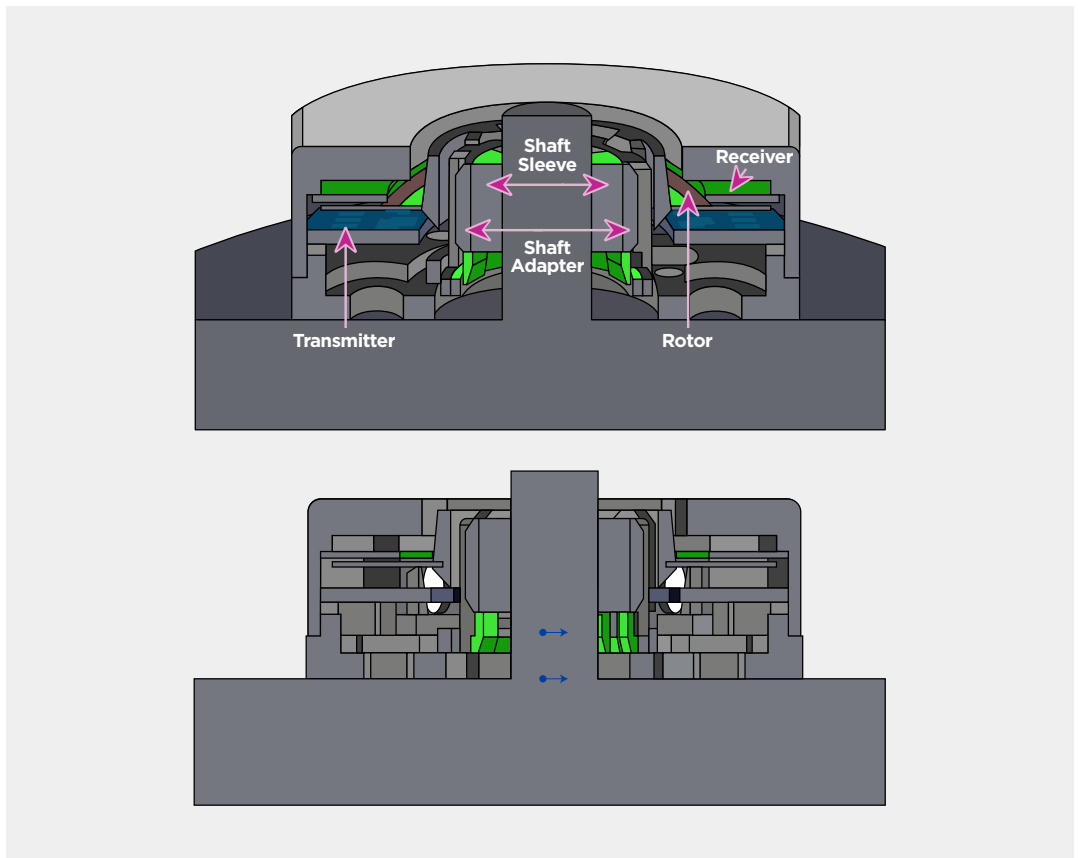
Figure 7

Improperly mounted encoder shows the way that this encoder was likely mounted with the internal rotor PCB not pushed down into place. This is consistent with the wear marks on the encoder.

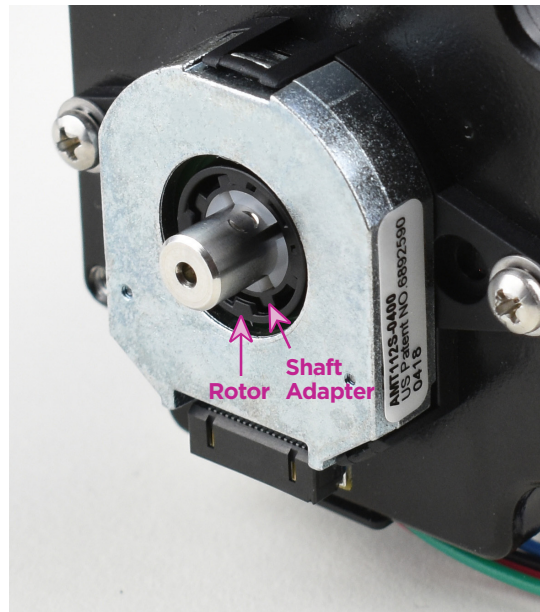
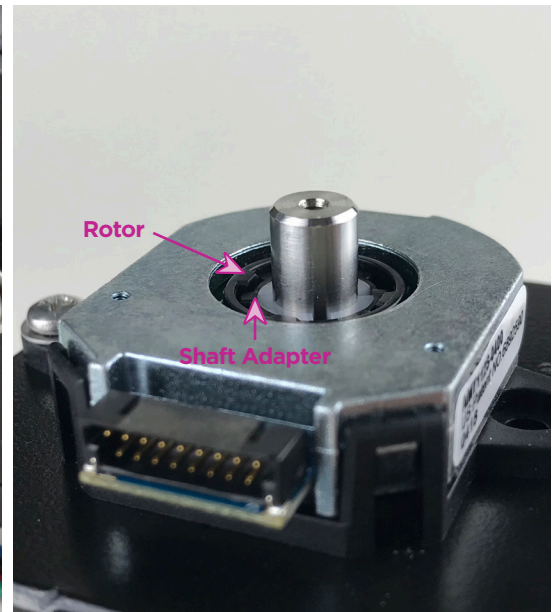
Figure 8

This shows the front view of the encoder rotor sitting too high and not flush with the shaft adapter. This is caused when Tool C is not utilized as outlined in step 6 of the mounting process shown below.
