## Product Change Notice (PCN)

**PCN Number:** PCN-0451152R-01

**Product(s) Affected:** PJ-038A, PJ-038B, PJ-038AH, PJ-038BH

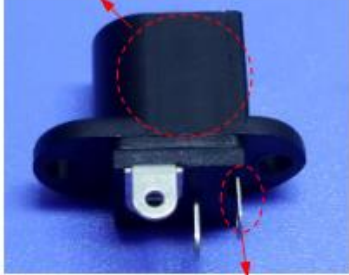
<p>Top</p>	<p>without injection mark</p>

<p>thickness of pin#2 is 0.2mm</p>	<p>with injection mark</p>

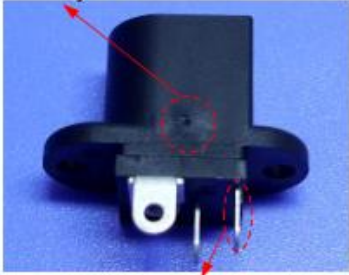
<p>thickness of pin#2 is 0.25mm</p>
<p>Bottom</p>	<p>rough surface with injection mark</p>

**Description of Change:** Thickness of pin 2 changed from 0.2mm to 0.25mm. Aesthetic changes as shown in below comparisons:

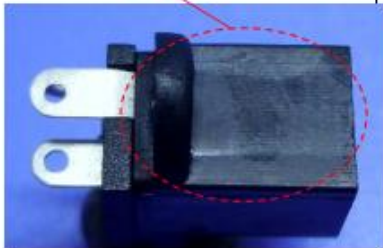
<p>A photograph of the same component as in the previous image. A red dashed circle highlights the surface of the tab, which appears smooth and uniform. A red arrow points from the text 'smooth surface' to this area.</p>
Left	<p>rough surface</p>

<p>A photograph of the component from a left-side perspective. A red dashed circle highlights the surface of the metal tab, which appears rough and textured. A red arrow points from the text 'rough surface' to this area.</p>	<p>smooth surface</p>

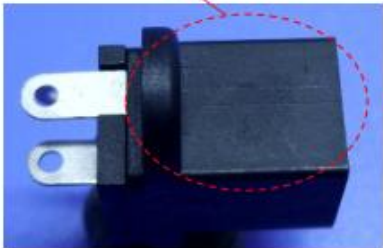
<p>A photograph of the component from a left-side perspective. A red dashed circle highlights the surface of the metal tab, which appears smooth and uniform. A red arrow points from the text 'smooth surface' to this area.</p>
