AMT Encoder Mounting Troubleshooting Guide

Applicable series: AMT11, AMT11A, AMT20, AMT21, AMT22, AMT23, AMT31

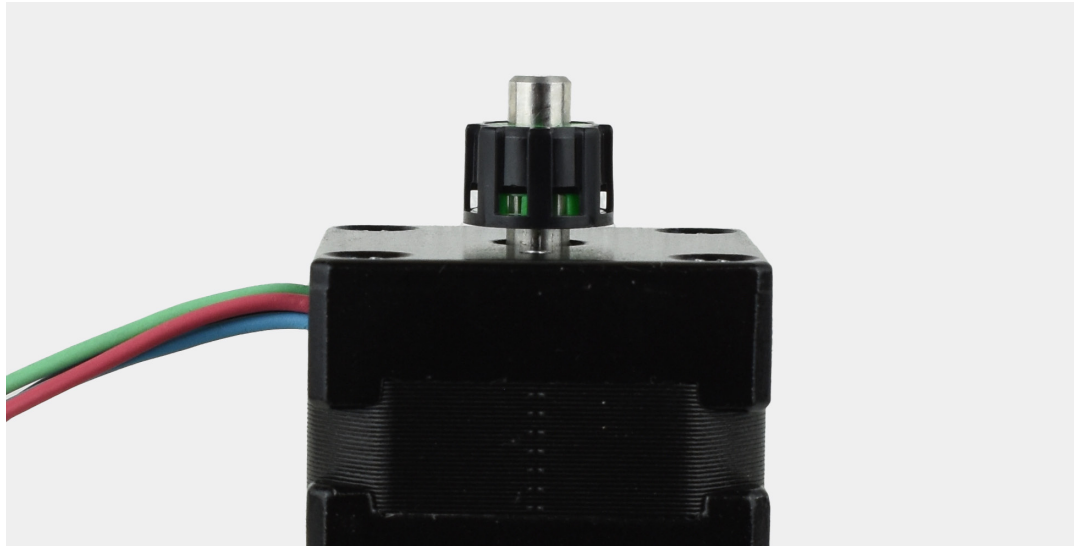
Figure 6

Properly installed shaft adapter and sleeve that are flush and properly spaced from the mounting surface

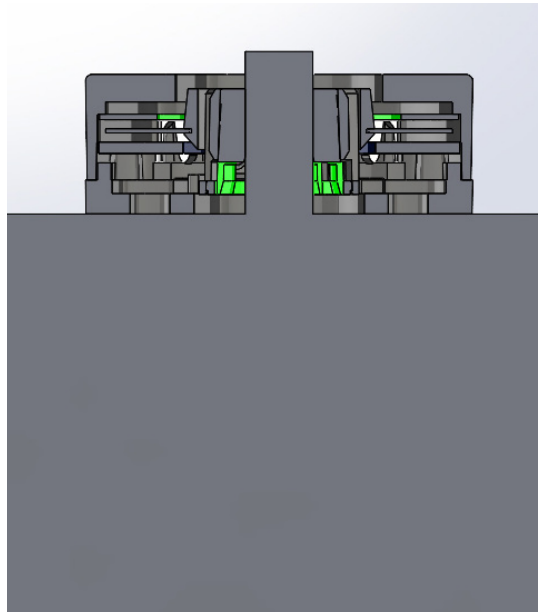
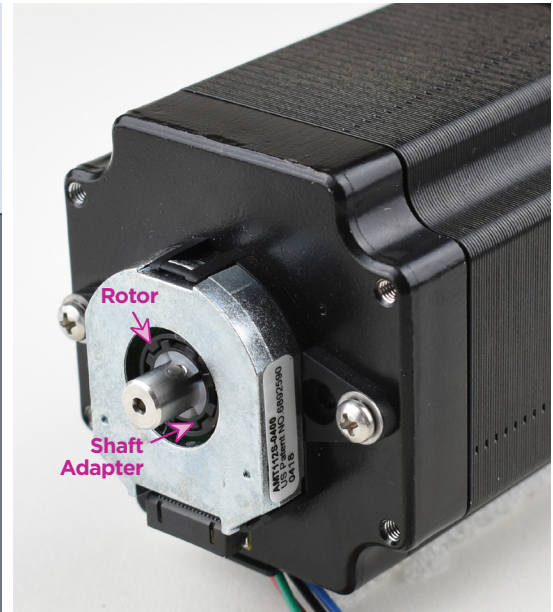
Figure 10

Properly installed encoder with internal rotor and shaft adapter now flush and properly seated within the encoder assembly. Once Tool C is used, the rotor PCB should be properly seated between the transmitter and receiver PCBs. The image on the right further shows the proper air gap and that there should be no physical contact within the encoder.
